CASE STUDY

Campbeltown Airport is located at Machrihanish, 3 nautical miles west of Campbeltown, near the tip of the Kintyre peninsula in Argyll and Bute on the west coast of Scotland. Lagan Aviation & Infrastructure were awarded the contract for the Campbeltown Runway Rehabilitation in 2021, as the runway was suffering from end-of-life age cracking and slurry seal repairs that needed replacement.

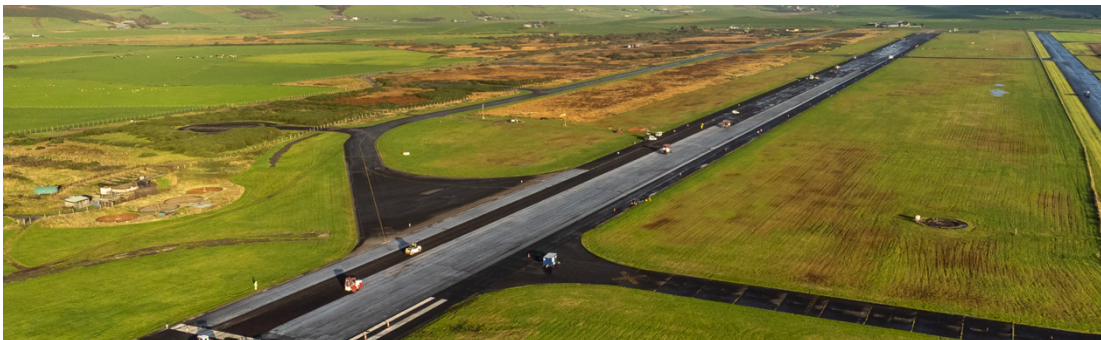
Lagan Airport Maintenance Ltd (LAML) was contracted by Lagan Aviation to carry out pavement maintenance works on the existing infrastructure adjoining the runway resurfacing. Saw cutting and joint sealing were carried out utilising N2 hot applied joint sealant on the existing pavement. Overbanding using OBS 45 was carried out on the runway shoulders and applied using our extruded sealant overbanding lance allowing high productivity each shift.

LAML also carried out coring for the installation of APAPI installation.

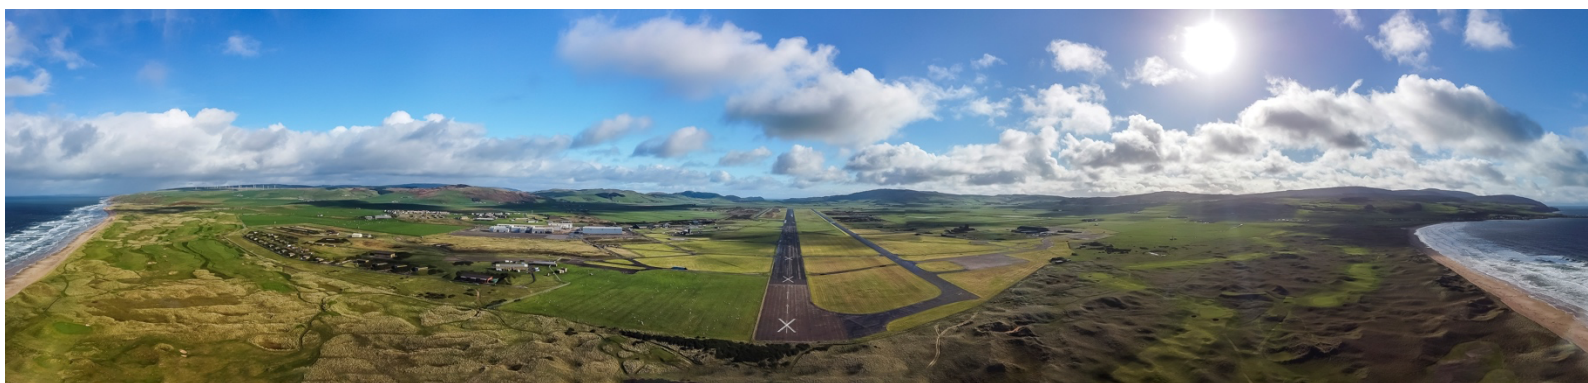
Overbanding was used to seal the larger cracks which prevent further water ingress to the asphalt/slurry seal surface of the runway shoulders and slows down the process of additional fretting. Helping to keep the surface free of water ingress and reduce FOD risks in the airside environment.
