CASE STUDY

Lagan Airport Maintenance Limited (LAML) were contracted to undertake Taxiway Refurbishment of Taxiway Romeo and Taxiway Bravo at Bournemouth Airport. Both taxiways were previously used as WWII Runways, and have been used more recently for A340 taxi operations. These primary routes onto the main runway, required refurbishment which included:

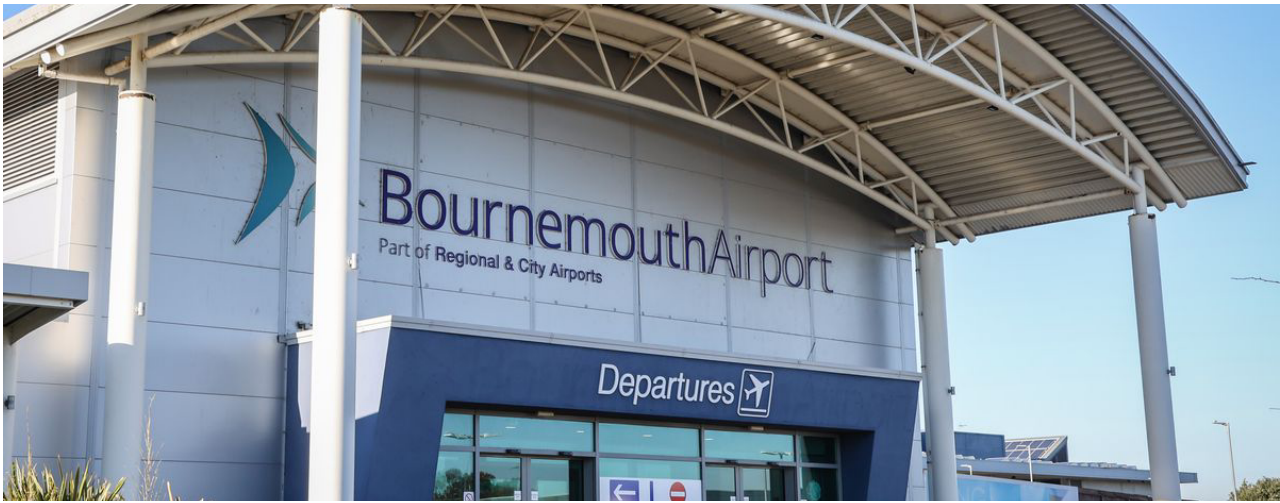
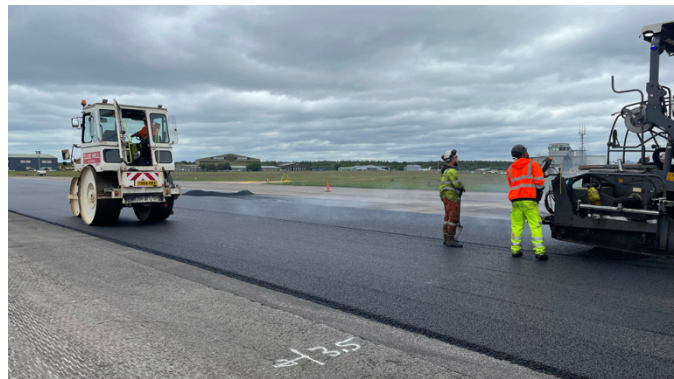
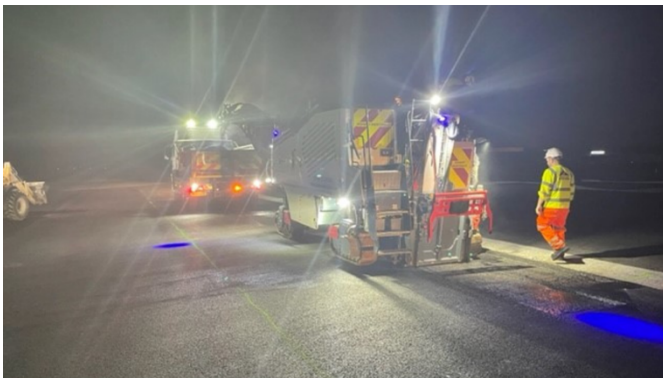
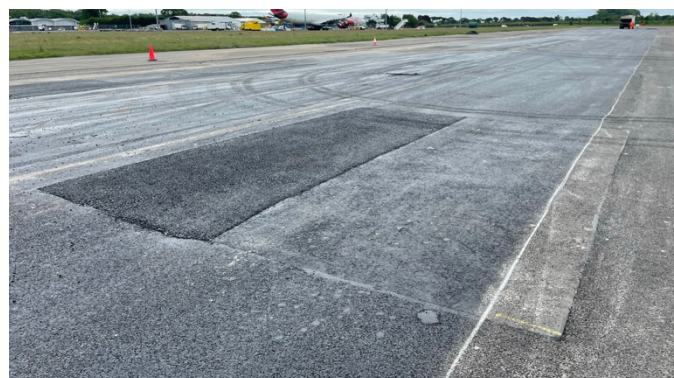
Asphalt Patching

To successfully plan the works, LAML undertook a joint inspection with the airport, measuring each patch in turn. The patching scope was to plane out, saw cut, clean, spray with K140, place asphalt to the required depth (80mm HDM Binder, 40mm SMA surface course). We reviewed core data and inspected the surface condition to ascertain if additional depth would be required due to the condition of the pavements that were being treated and allowed an amount for regulating material should this be required. Line markings were reinstated where required in patched locations.
